**SOLID AND HAZARDOUS WASTE MANAGEMENT BRANCH
COMPLIANCE ASSESSMENT**

SUBJECT: Compliance Assessment at Procino Plating FILE

GENERATOR/TSD LOCATION ADDRESS: 901 South Market Street
Seaford, Delaware 19973

PURPOSE OF ASSESSMENT: Follow-up Inspection (FUI) and Sampling

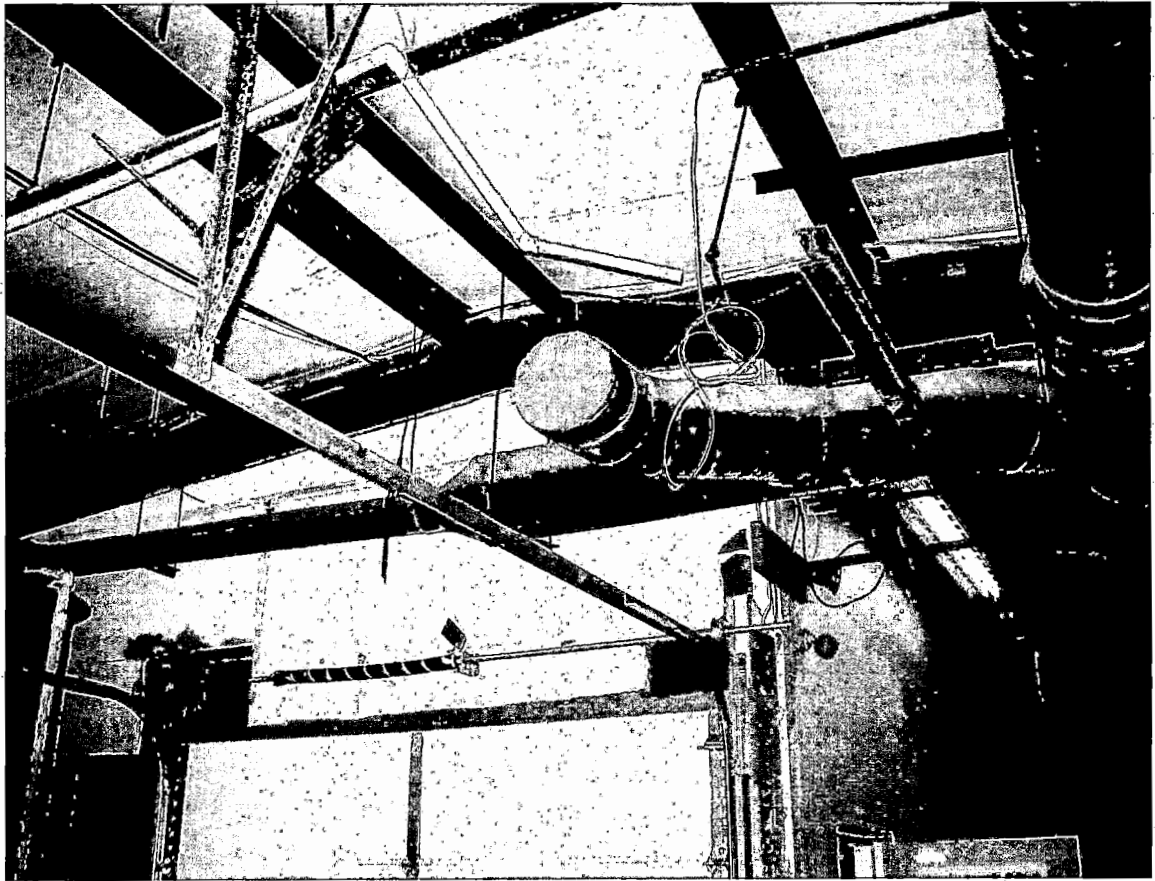
Photograph #30

SHWMB representatives observed open-ended piping/ductwork in the area across from the Wastewater Treatment Unit. The two doors shown in the bottom of the picture lead into the potential French Fry manufacturing area in Building #2.

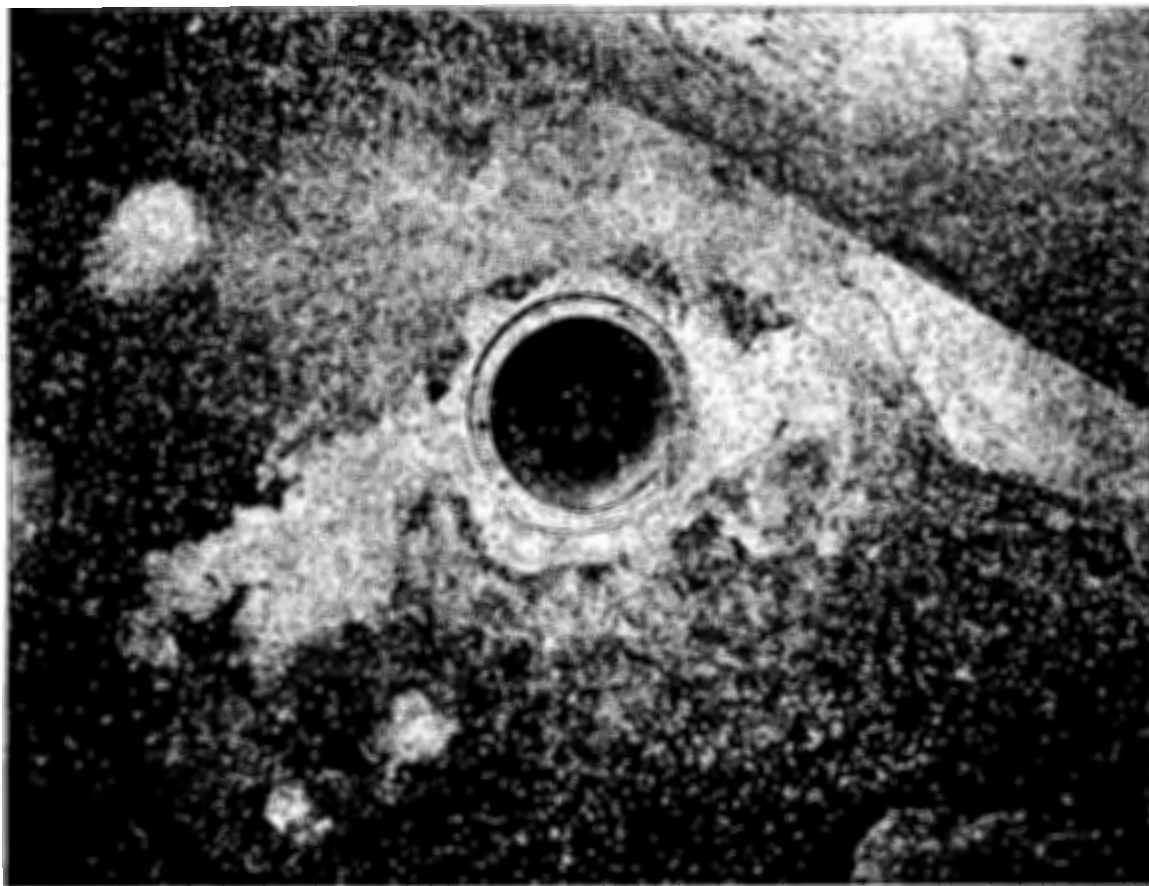
Photograph #31

SHWMB representatives observed a PVC pipe in the concrete floor in Building #2. Refer to the "Zoom In of Drum/Container Storage Area" for the location of the pipe.

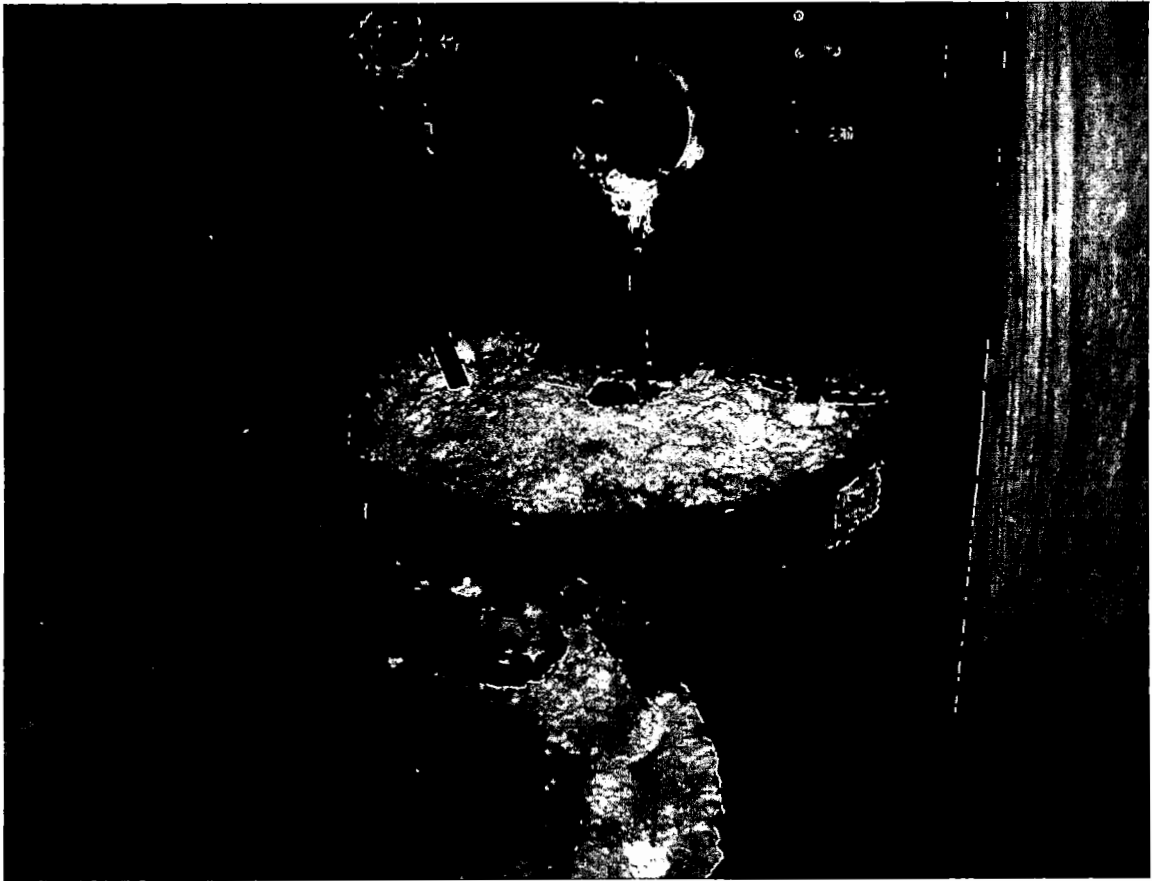
Photograph #32

SHWMB representatives observed several drums of chemicals used in the facility's on-site wastewater treatment unit.

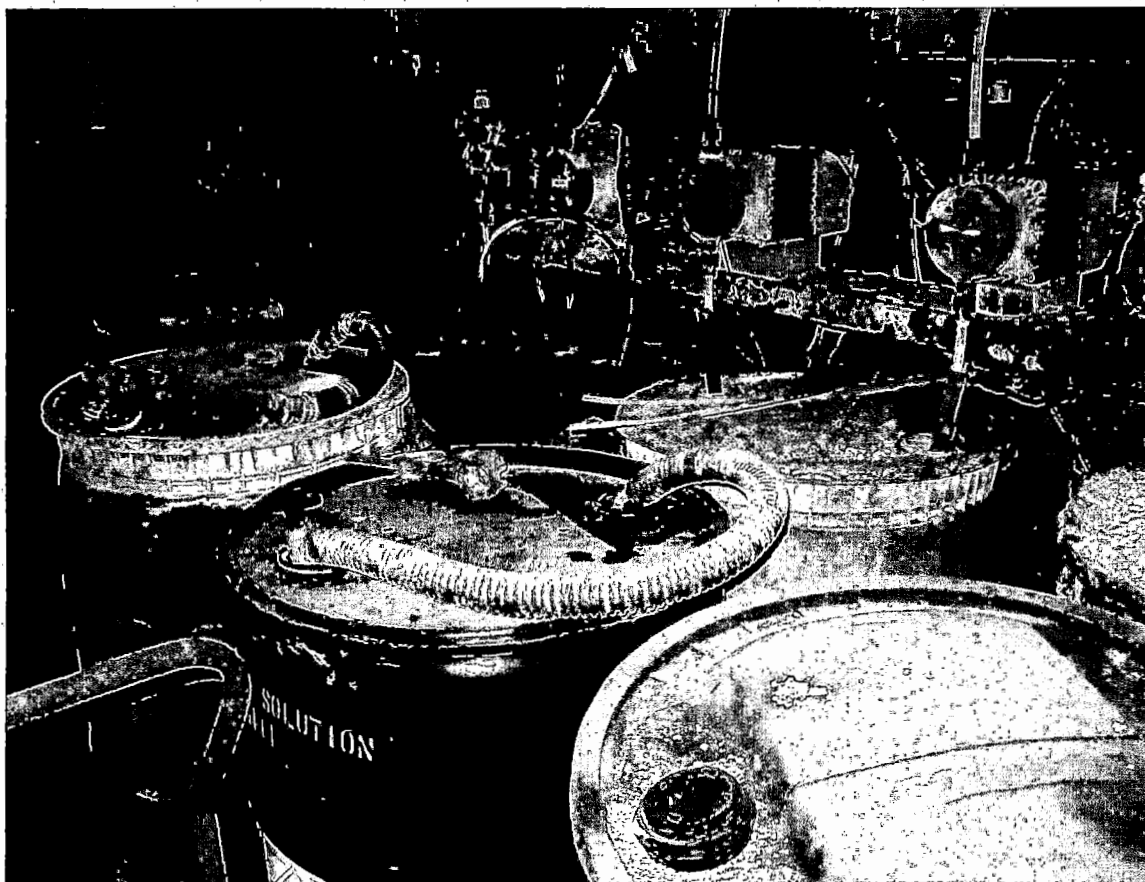
Photograph #33

SHWMB representatives observed several drums of chemicals used in the facility's on-site wastewater treatment unit.

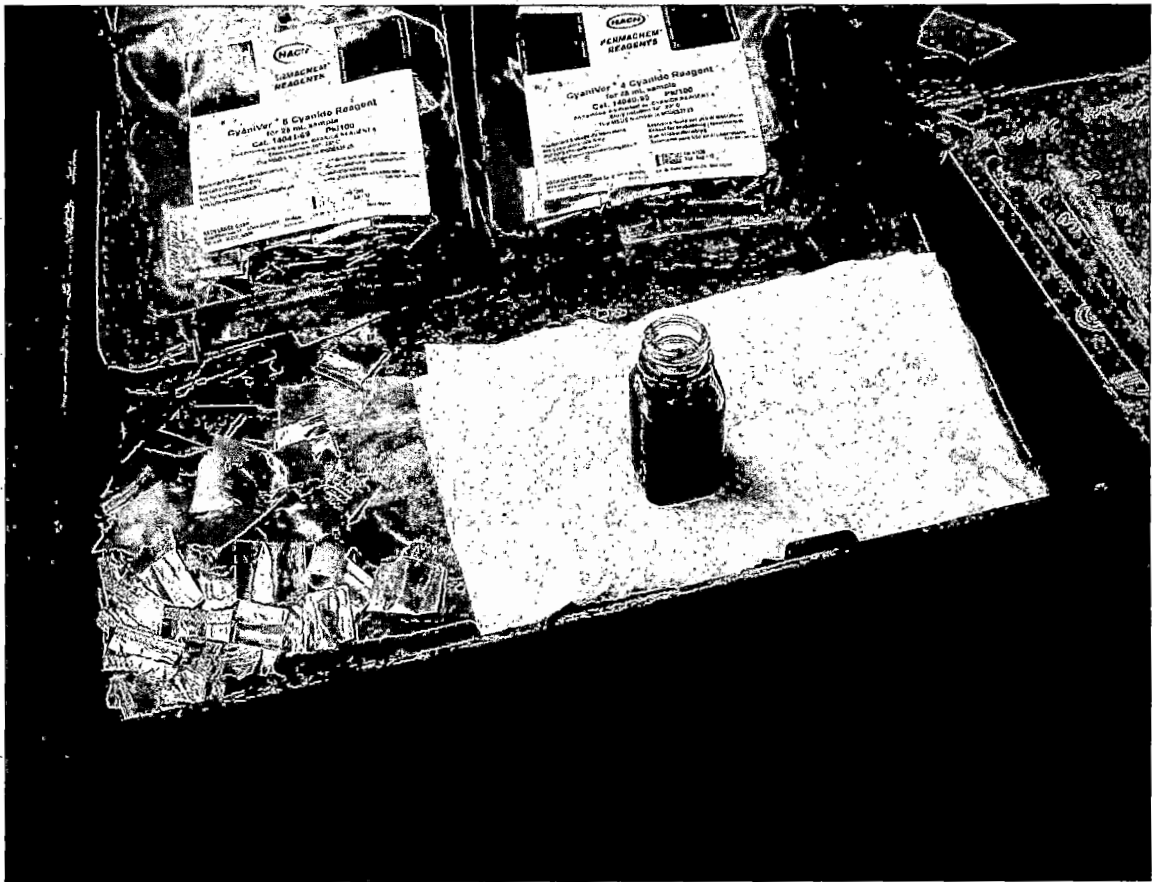
Photograph #34

SHWMB representatives observed a vial of liquid on the table next to the wastewater treatment unit. It was unclear at the time of the assessment what was in the vial or how the facility disposes of this waste stream.

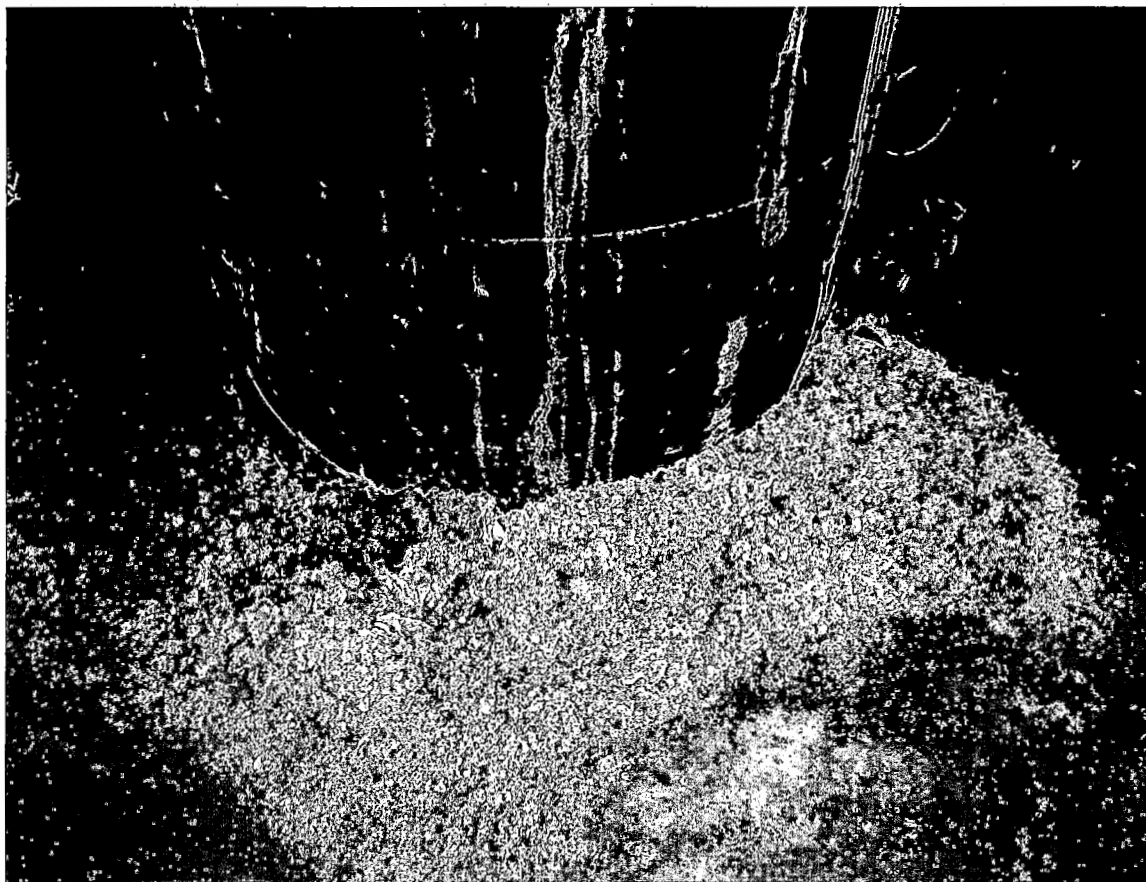
Photograph #35

SHWMB representatives observed an unknown solid on the ground near the table located next to the wastewater treatment unit.

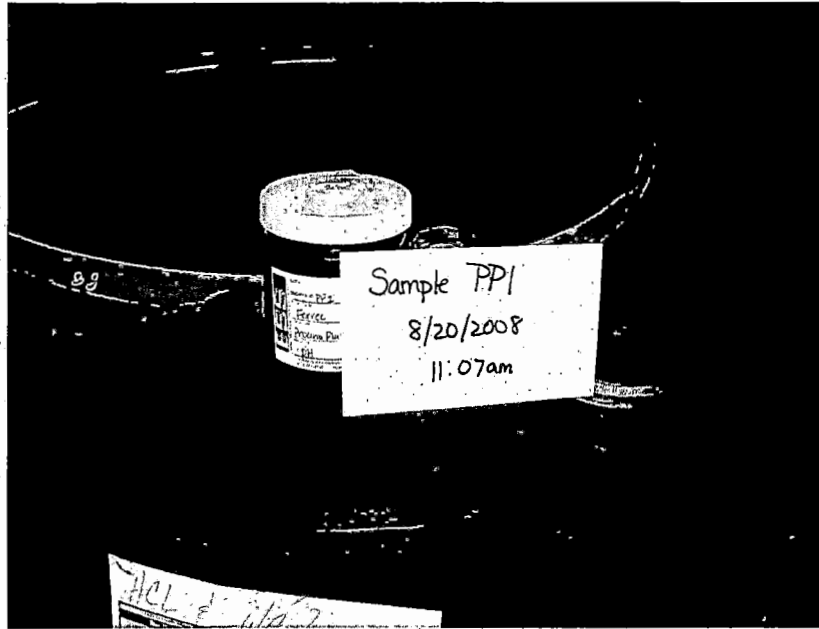
Photographs #36 and 37

SHWMB representatives obtained a sample from Container #17 to be analyzed for pH.

SHWMB representatives observed six – 55 gallon poly drums of hydrochloric acid and water (Containers 1, 17, 18, 19, 41, and 42 on the Container Log in Attachment 1). Mr. Procino stated during the February 5, 2008 follow-up compliance assessment and again on August 20, 2008 that this waste stream had a pH of approximately 1 and acknowledged that they were a hazardous waste. SHWMB representatives determined through the use of pH paper that the pH of Drum #17 was 1. SHWMB representatives proceeded to obtain samples of Drums 17, 18, 19, 41, and 42 to be analyzed for pH by the DNREC Environmental Laboratory Section (Attachment 2 and Photographs 36-45). The results are summarized in the table below:

Two of the containers (Drums 17 and 18) were incorrectly marked with an accumulation start date of July 9, 2008. These containers were observed by the SHWMB during the July 1, 2008 assessment. In addition, SHWMB representative Melissa Ferree spoke to Mr. Procino via telephone on July 7, 2008 and discussed the need to determine the accumulation start date and to label the containers with the appropriate start date. This is also a violation of DRGHW §262.34(a)(2), which states:

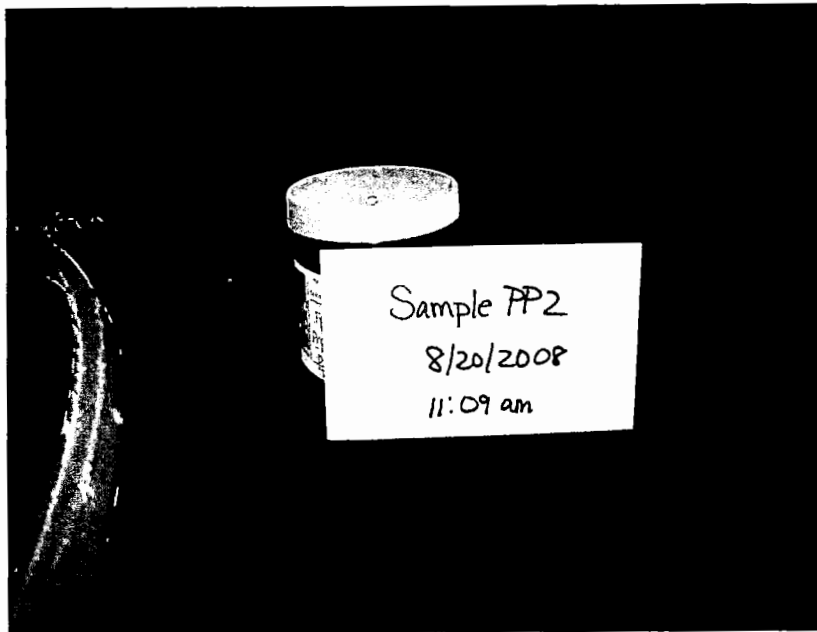
Photographs #38 and 39

SHWMB representatives obtained a sample from Container #18 to be analyzed for pH.

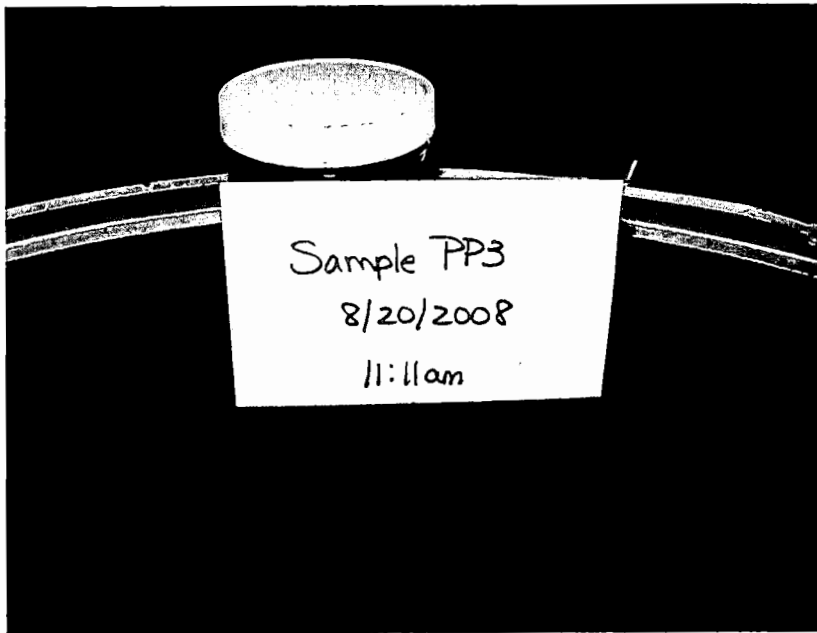
Photographs #40 and 41

SHWMB representatives obtained a sample from Container #19 to be analyzed for pH.

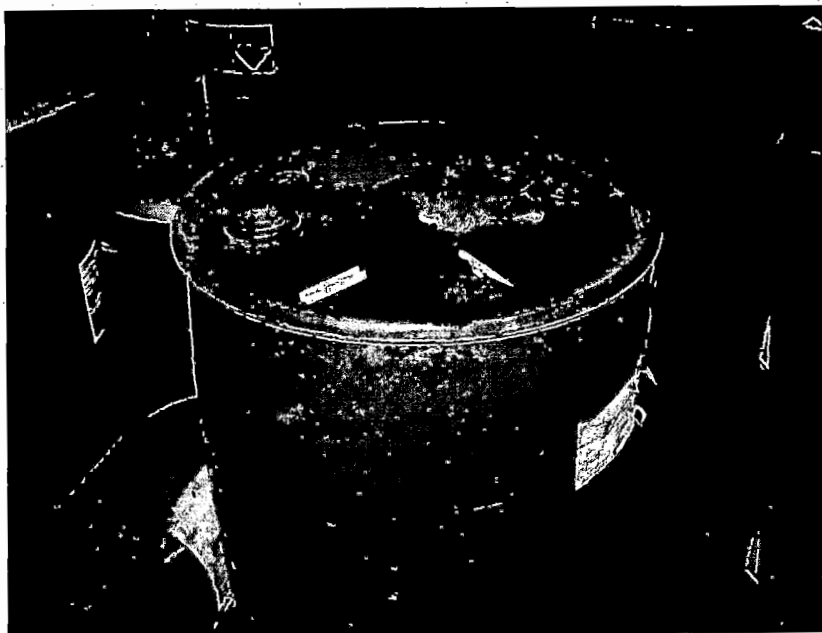
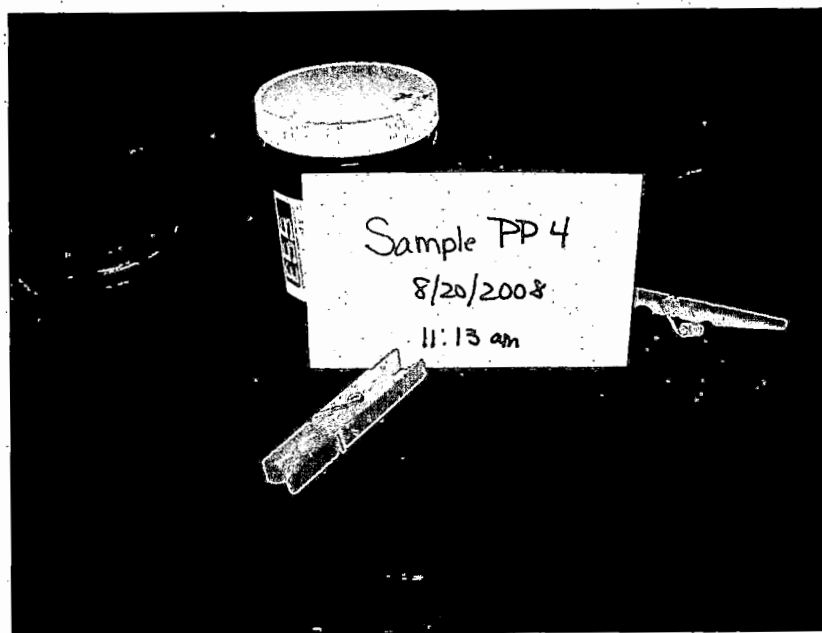
Photographs #42 and 43

SHWMB representatives obtained a sample from Container #42 to be analyzed for pH.

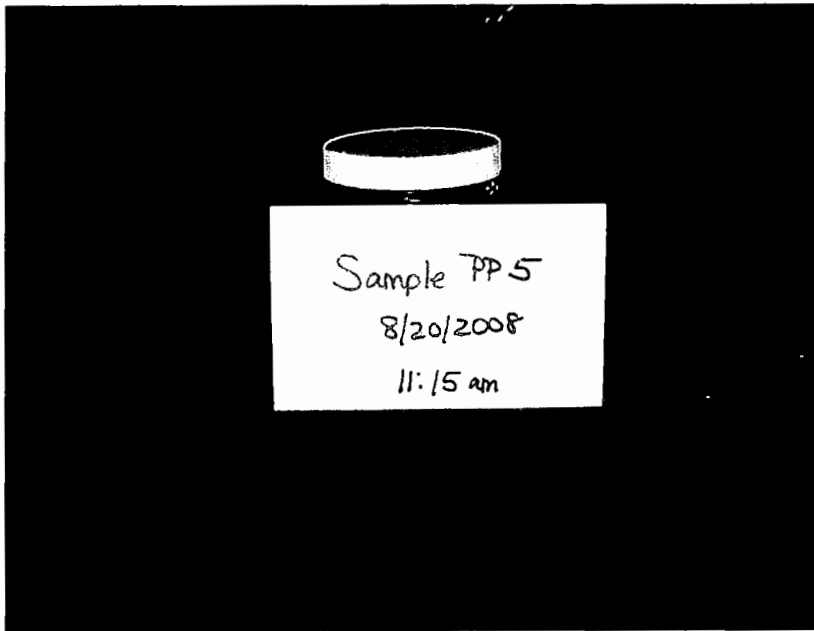
Photographs #44 and 45

SHWMB representatives obtained a sample from Container #41 to be analyzed for pH.
